Final Report 15 May 2015

Investigation of the effectiveness of bat and bird detection of the DTBat and DTBird systems at Calandawind turbine

3MW Wind Turbine
Calandawind AG
Feldstrasse 17
7023 Haldenstein
www.calandawind.ch

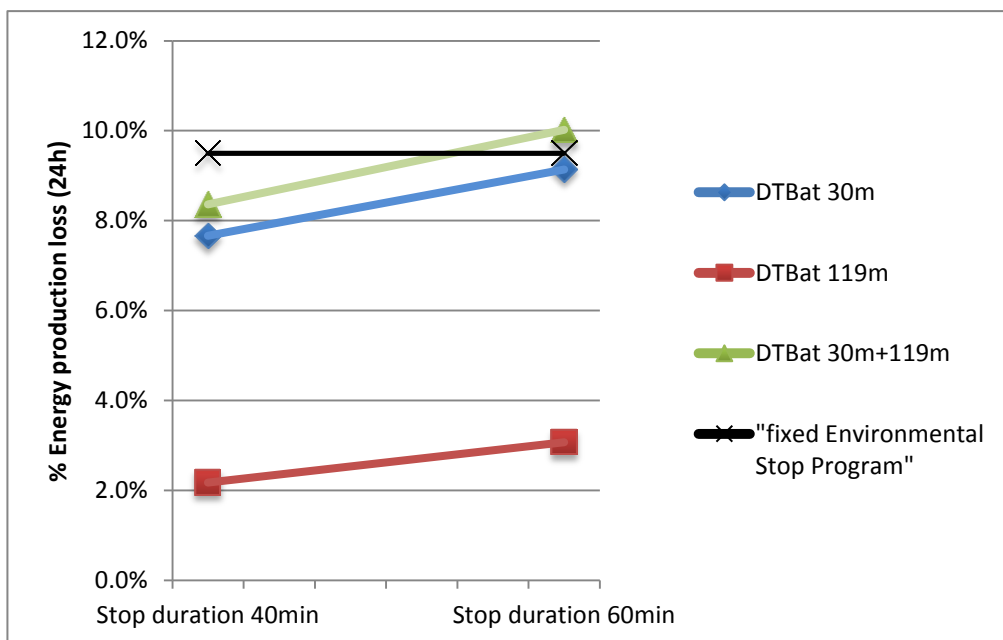
Fig. 4 Comparison of energy production loss (%) in relation to total energy in the "Assessment Period" using different stop algorithms and stop durations. An estimate of annual energy loss is about 3 times smaller (Annex III - Fig. 13)

both SWILD and DTBat algorithms, annual production loss with DTBird algorithms will be in the same order of magnitude, that is approximately 3% (see also Tab. 1).

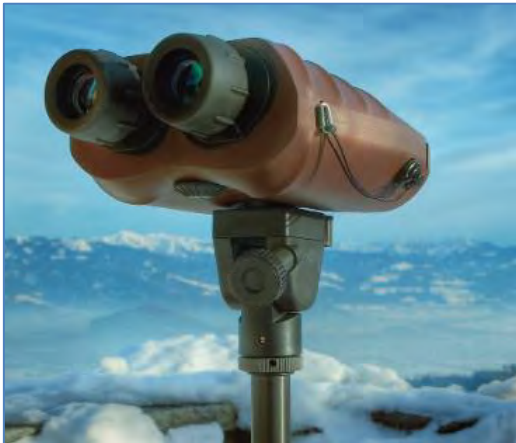
Fig. 5. Laser range finder Vector 21 Aero (www.vectronix.ch).

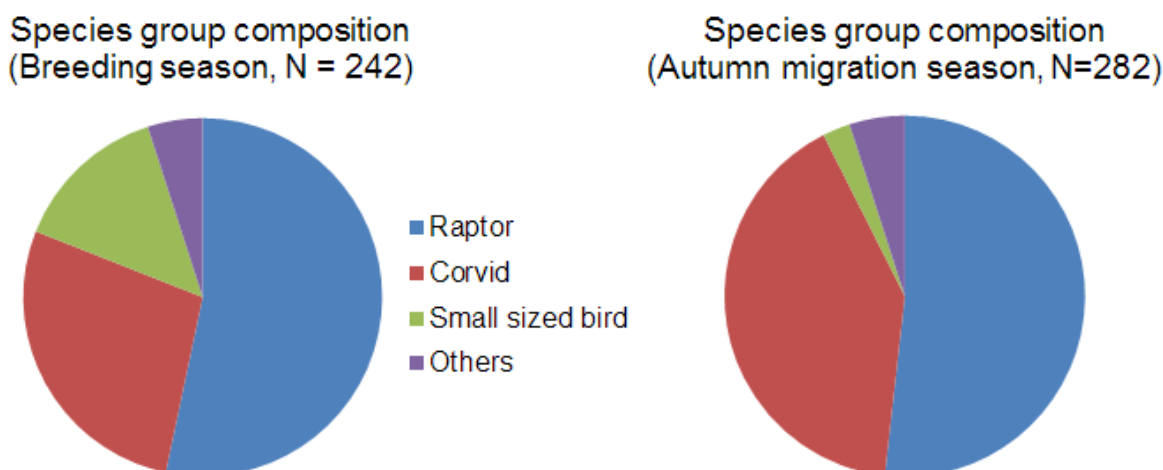
Fig. 20. Species group composition of direct visual observations during breeding season (left, 06.05.-16.06.2014) and during autumn migration season (right, 22.08.-26.10.2014).

The second frequent observed species group was Corvids (Northern Raven *Corvus corax* and Carrion Crow *Corvus corone*). The group “small sized bird” mainly includes Common Swift (*Apus apus*) and Alpine Swift (*Apus melba*) while the group “Others” includes Grey Heron (*Ardea cinerea*), White Stork (*Ciconia ciconia*), Great Cormorant (*Phalacrocorax carbo*), Gulls and Doves.

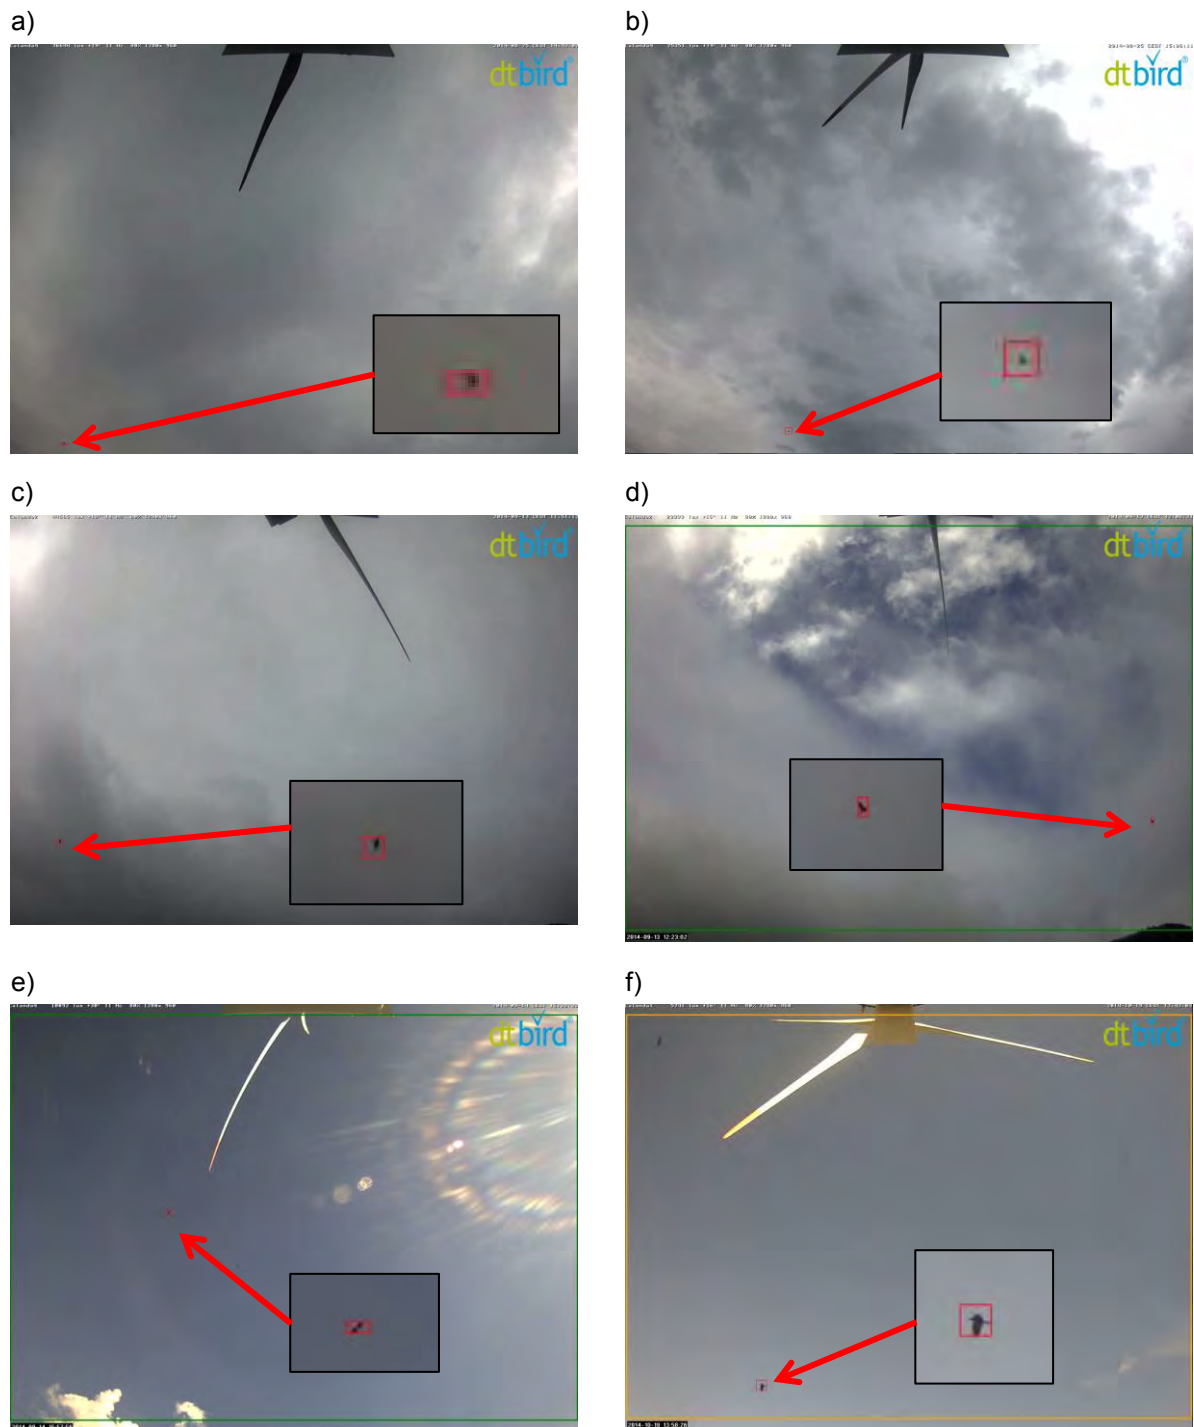
Fig. 23. Screen shots of the DTBird videos and increased detail of the bird. a) Corvid (ID 52), b) Corvid (ID 53), c) Corvid (ID 540), d) Medium sized bird (ID 541) e) Big-sized bird (ID 571) f) Corvid (ID 1160).

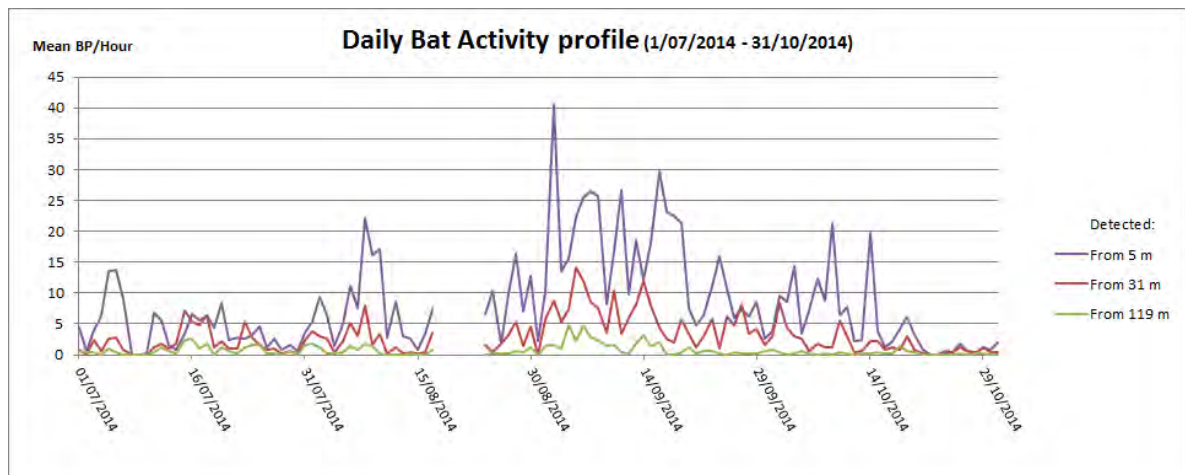
Figure 1. *BA* per night (as mean *BP*/hour registered every night) along the monitoring period, 01/07/2014 to 31/10/2014, at the 3 heights of the WTG Calandawind.

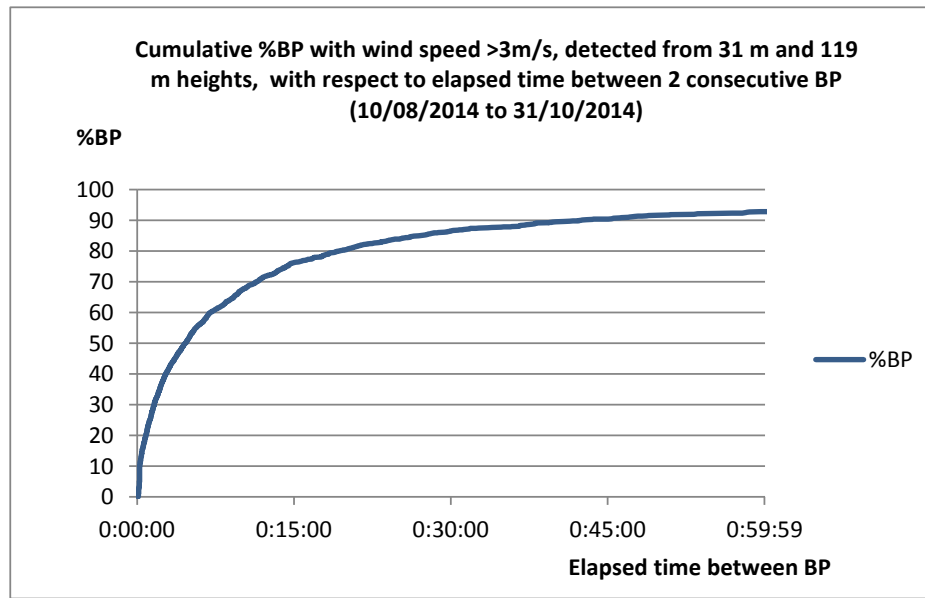
Figure 4. Cumulative %*BP* with wind speed >3m/s, detected from 31 m and 119 m heights, with respect to the elapsed time between 2 consecutive *BP*, for the period 10/08/2014 to 31/10/2014.

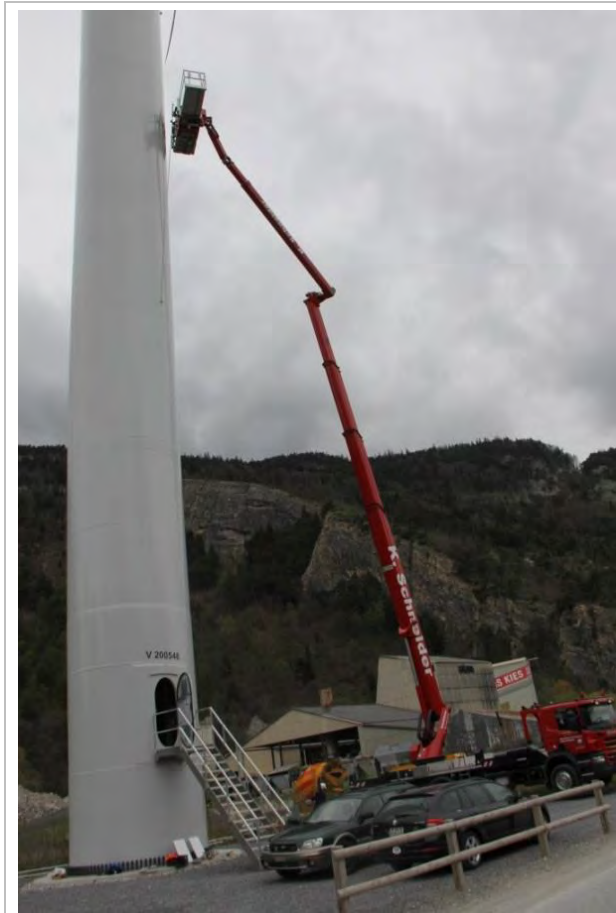
Installation at 31m height with man-lift
